Reconstruction of the Aortic Valve and Root  
A Practical approach

# Failures after aortic valve repair

Diana Aicher

September 16<sup>th</sup>-18<sup>th</sup> 2015

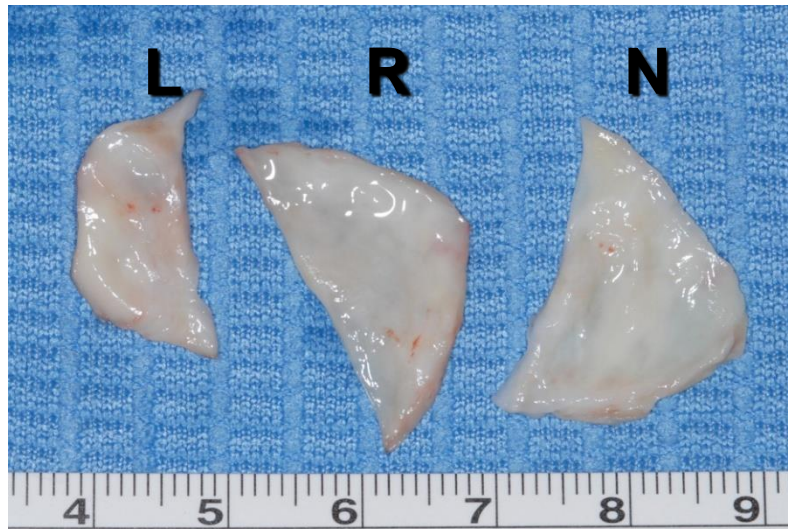
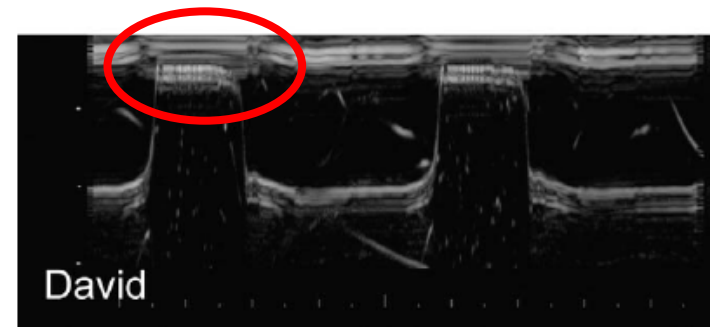
### Secondary cusp retraction

Intraoperative photograph of excised aortic cusps from a patient with Marfan syndrome 10 years after reimplantation

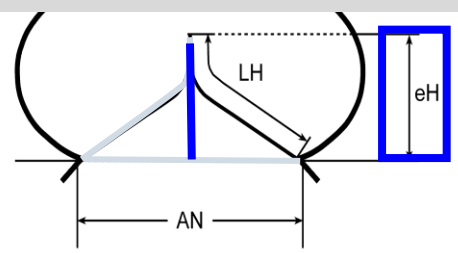
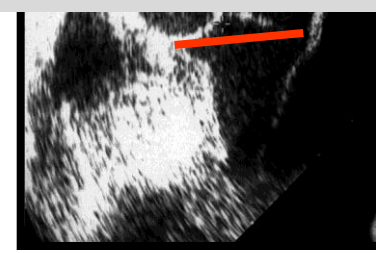
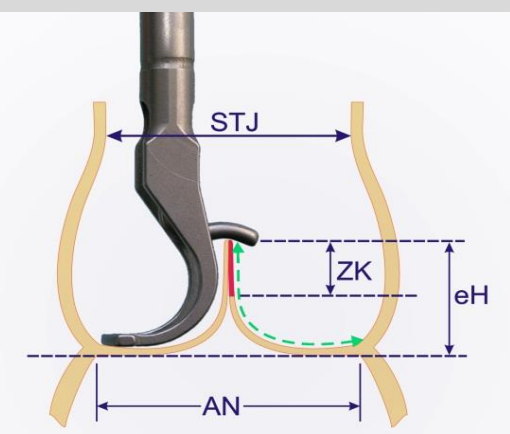
### Effective height as indicator for cusp prolapse

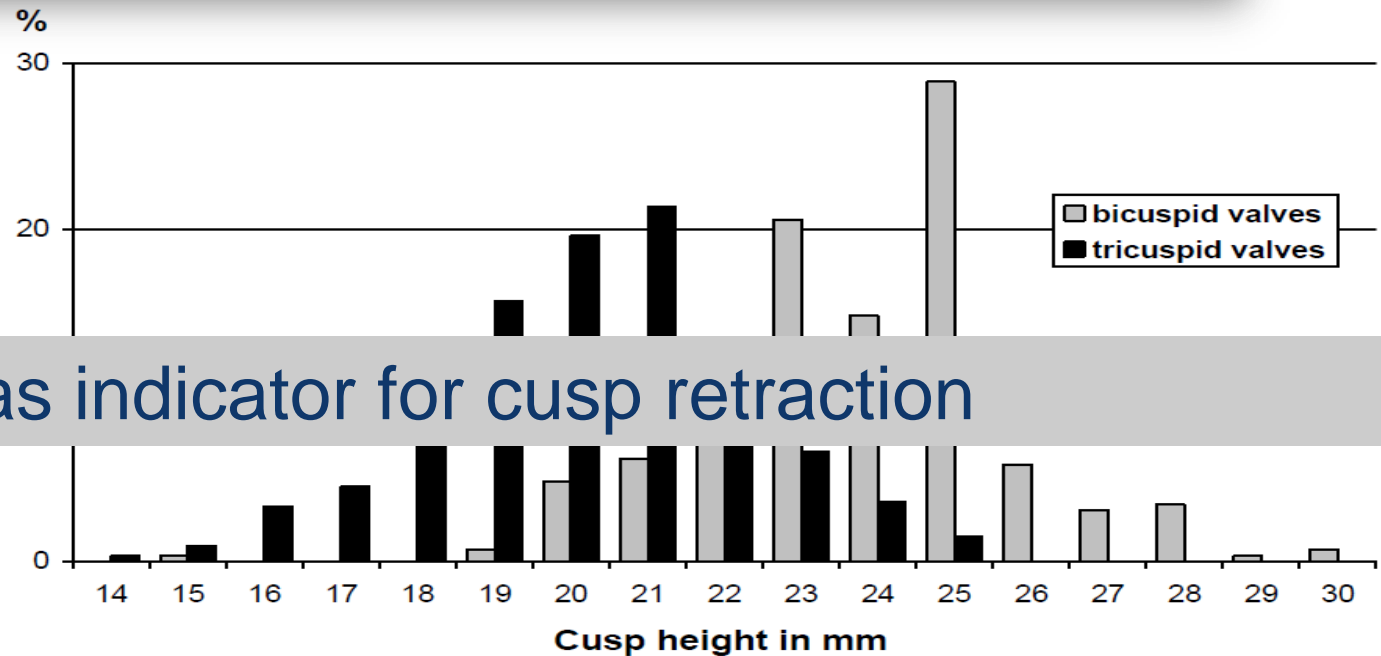
Mean geometrical height:

Bicuspid  $24 \pm 2\text{mm}$

Tricuspid  $21 \pm 3\text{mm}$

gH as indicator for cusp retraction

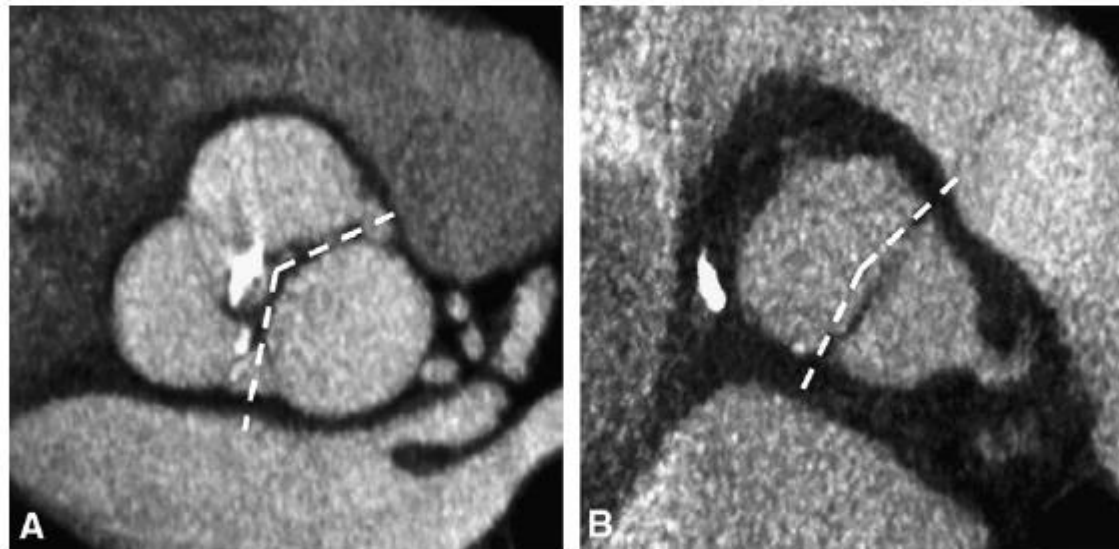
**FIGURE 1.** Computed tomography of an aortic root with BAV preoperatively (A) and postoperatively (B). The commissural orientation of the commissures of the nonfused cusps (*dotted lines*).

#### Commissural orientation before and after root remodeling

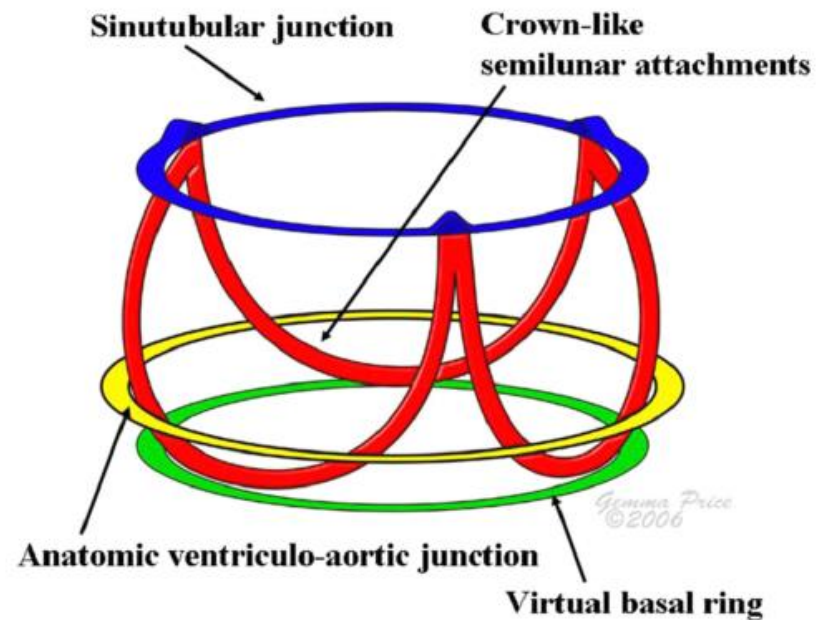
# Insufficient commissural height

45 year old female with recurrent regurgitation after reimplantation of a BAV 6 months ago

- BAV: Fusion of right and noncoronary cusp
- Prolapse of both cusps
- limited perforation of the left cusp
- insufficient commissural height
- AV diameter 25mm
